# REGENERATION REVIEW

## Dunbar East Beach 2025

Dunbar  
Shore and Harbour  
Neighbourhood Group  
*....making it better beside the sea....*

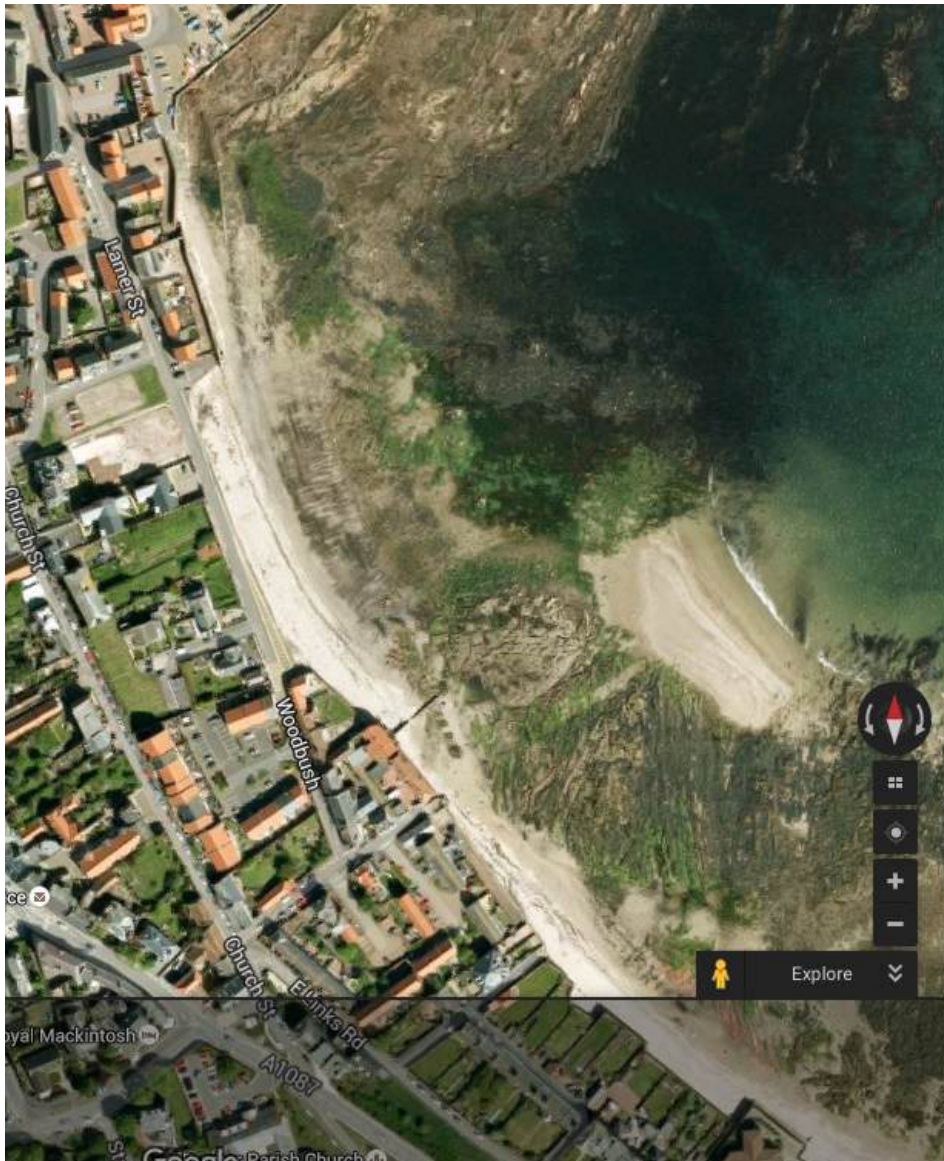
### East Beach – Aerial View 2016

Beach regenerated naturally. No breakwaters  
Sand on beach, no pipeline visible

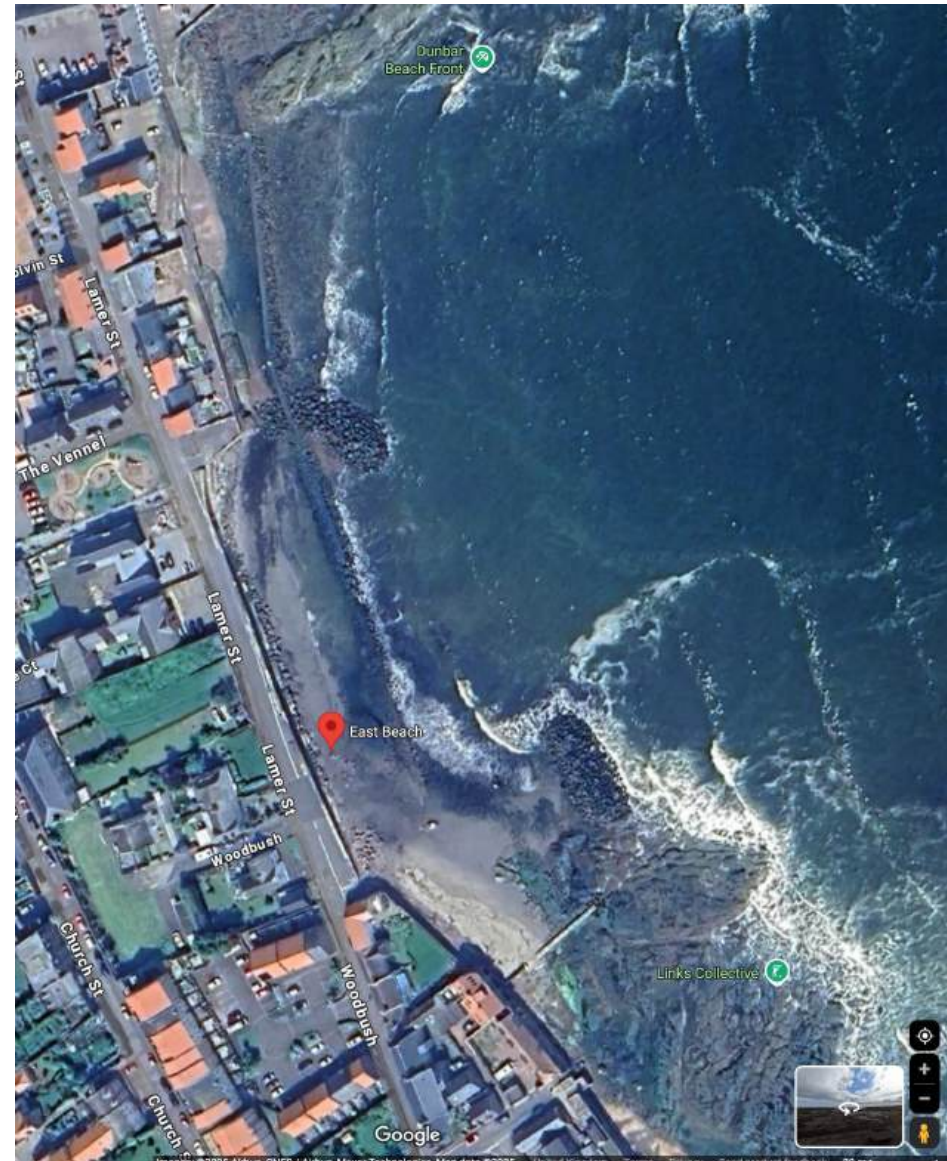
### East Beach – Aerial View 2025

Breakwaters in place. Beach completely denuded of  
sand

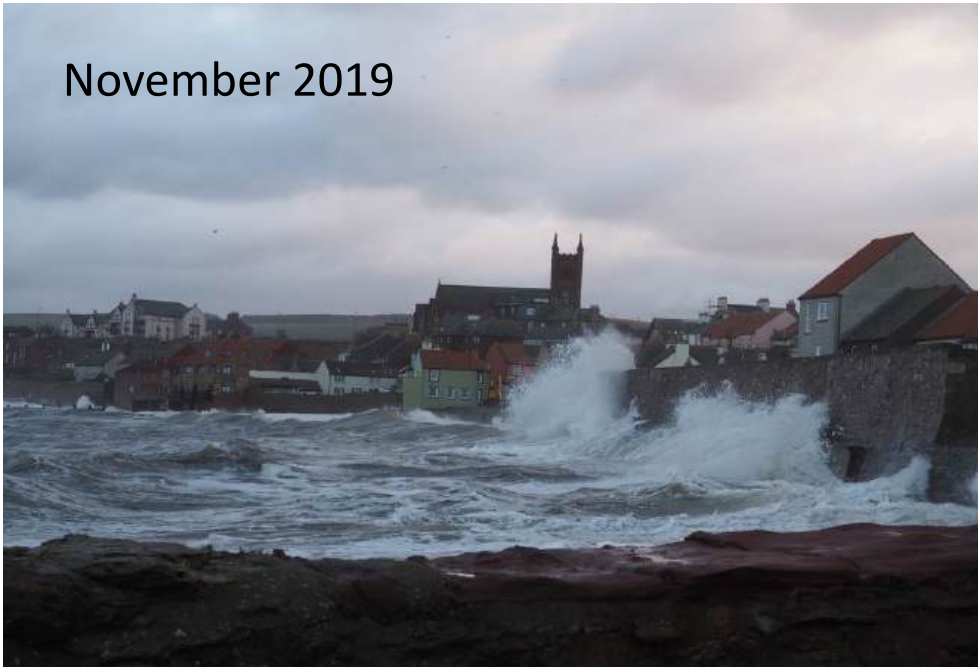
November 2019

**Heavy seas and large swells continue to impact the sea wall** which retains loose, fill material below the long established Lamer Street. Even small holes in the wall allow loose material to be drawn out, resulting in the collapse of the road. There have been four such collapses in the past 15 years, with a major collapse in 2023, 3 years after completion of the new sea defences. East Lothian Council continue to monitor and instruct periodic repair to the masonry and pointing to preserve the integrity of the wall as far as possible, but it seems inevitable that the wall will fail or become economically non-viable to patch and reactively repair damage.

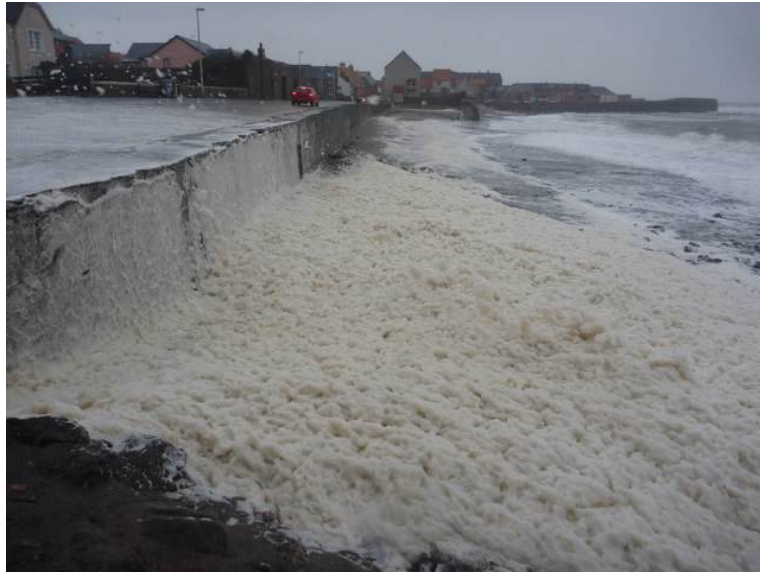
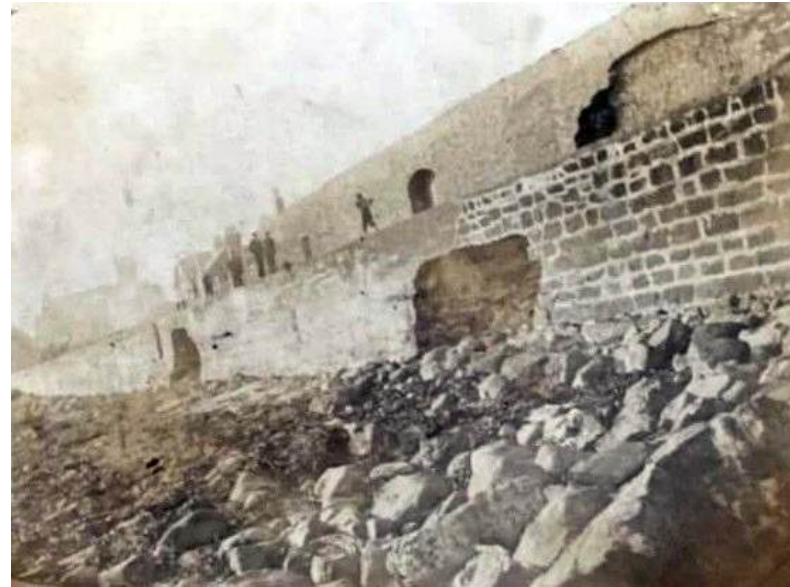
Sea wall  
vulnerable to  
wave attack  
and  
subsequent  
road/building  
collapse
