# REGENERATION REVIEW

## Dunbar East Beach 2025

Dunbar  
Shore and Harbour  
Neighbourhood Group  
*....making it better beside the sea....*

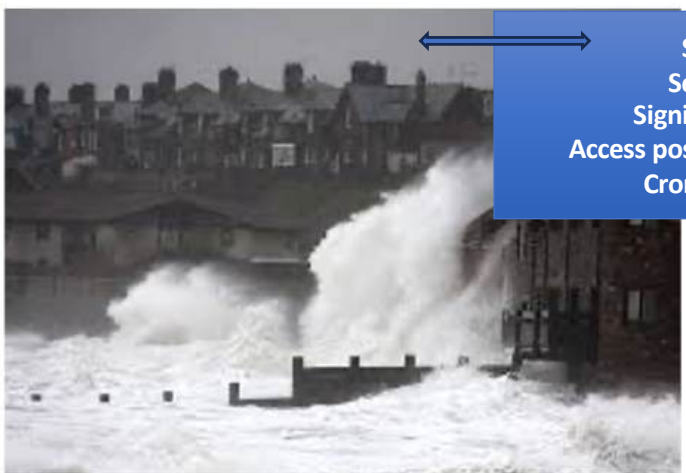
**2014 – 2015**  
Continuing sand loss  
Access not possible by tractor from Cromwell Harbour. Beach scoured to bedrock and groyne damaged further
